**COAL MINE SAFETY AND HEALTH
REPORT OF INVESTIGATION**

**Fatal Powered Haulage Accident
January 30, 2003**

**Mine #10
AEP Kentucky Coal, L.L.C.
Dorton, Pike County, Kentucky
ID No. 15-07763**

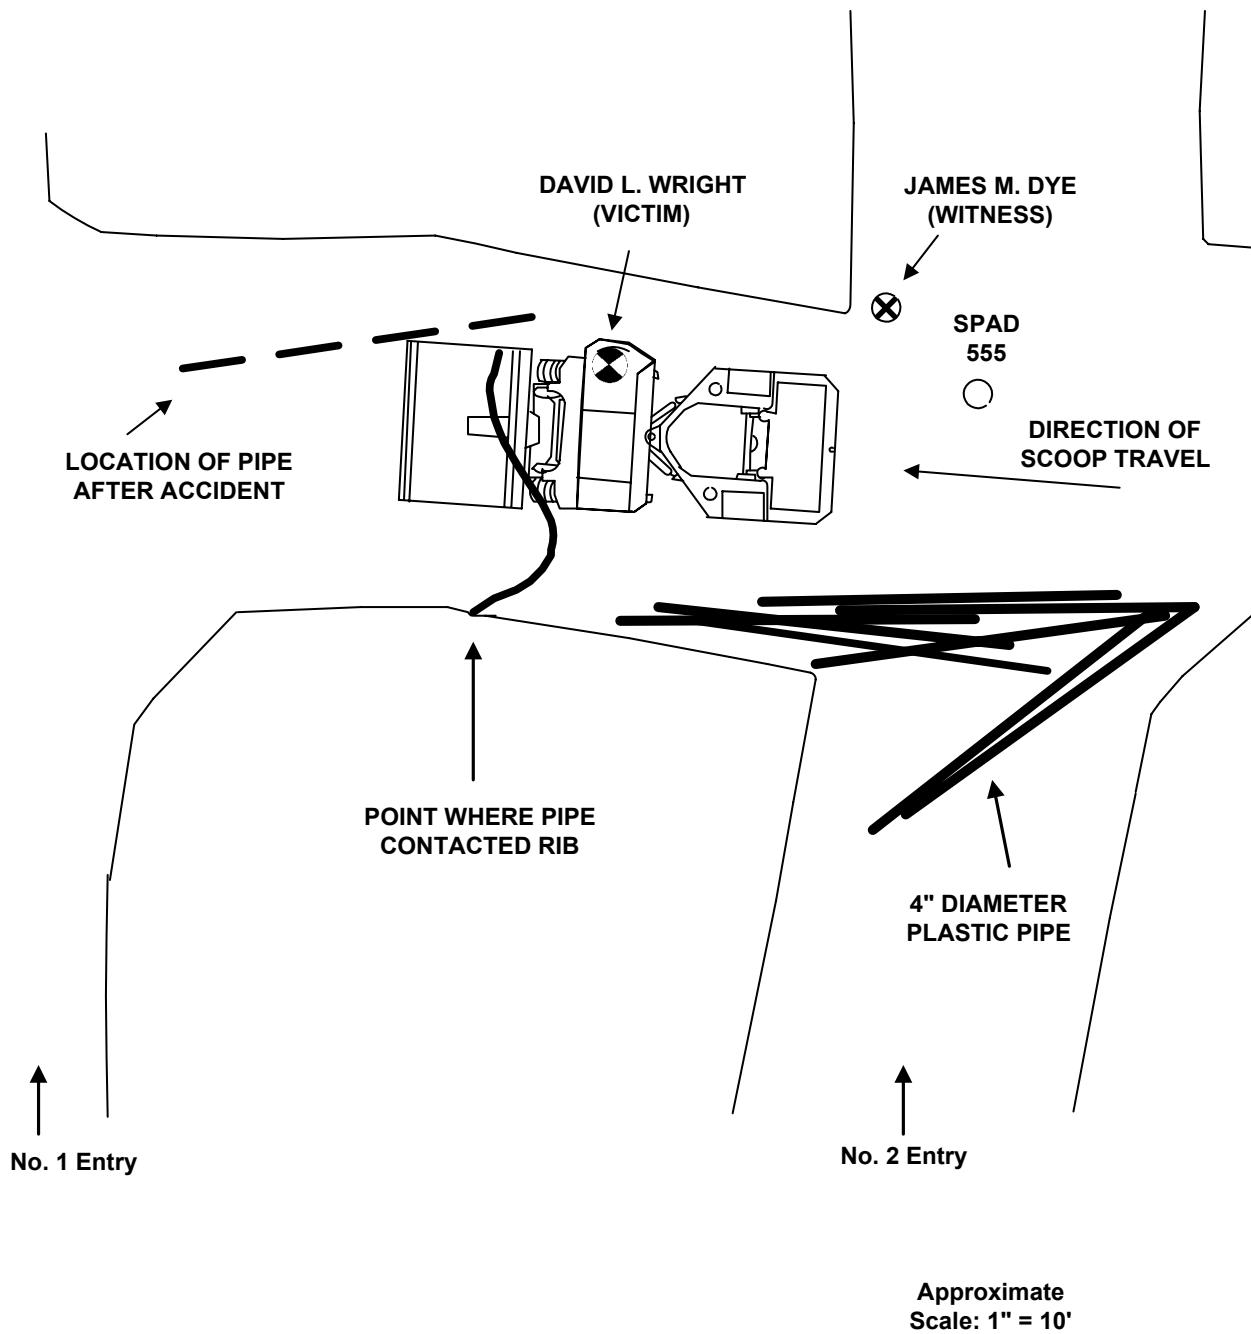
FATAL HAULAGE ACCIDENT
AEP KENTUCKY COAL, LLC
MINE NO. 10
15-07763
DORTON, PIKE COUNTY, KENTUCKY
JANUARY 30, 2003

Wright returned to the scoop and proceeded to remove the stopping between the No. 2 and No. 3 entries just outby Spad 555. As Wright was transporting a load of concrete blocks and roadway material through the crosscut between the No. 1 and No. 2 entries, the scoop bucket contacted a 20-foot long, 4-inch diameter plastic water pipe. The pipe, which became caught on the coal rib and was bent by the force of the scoop's motion, slipped out of the scoop bucket and bounced into the operator's deck of the scoop. The end of the pipe, which was equipped with a metal coupling, struck the victim on the right side of the head.

1. James Michael Dye was the only eyewitness to the accident.
2. The accident occurred in the crosscut between No. 1 and No. 2 Entries at Survey Station 555.

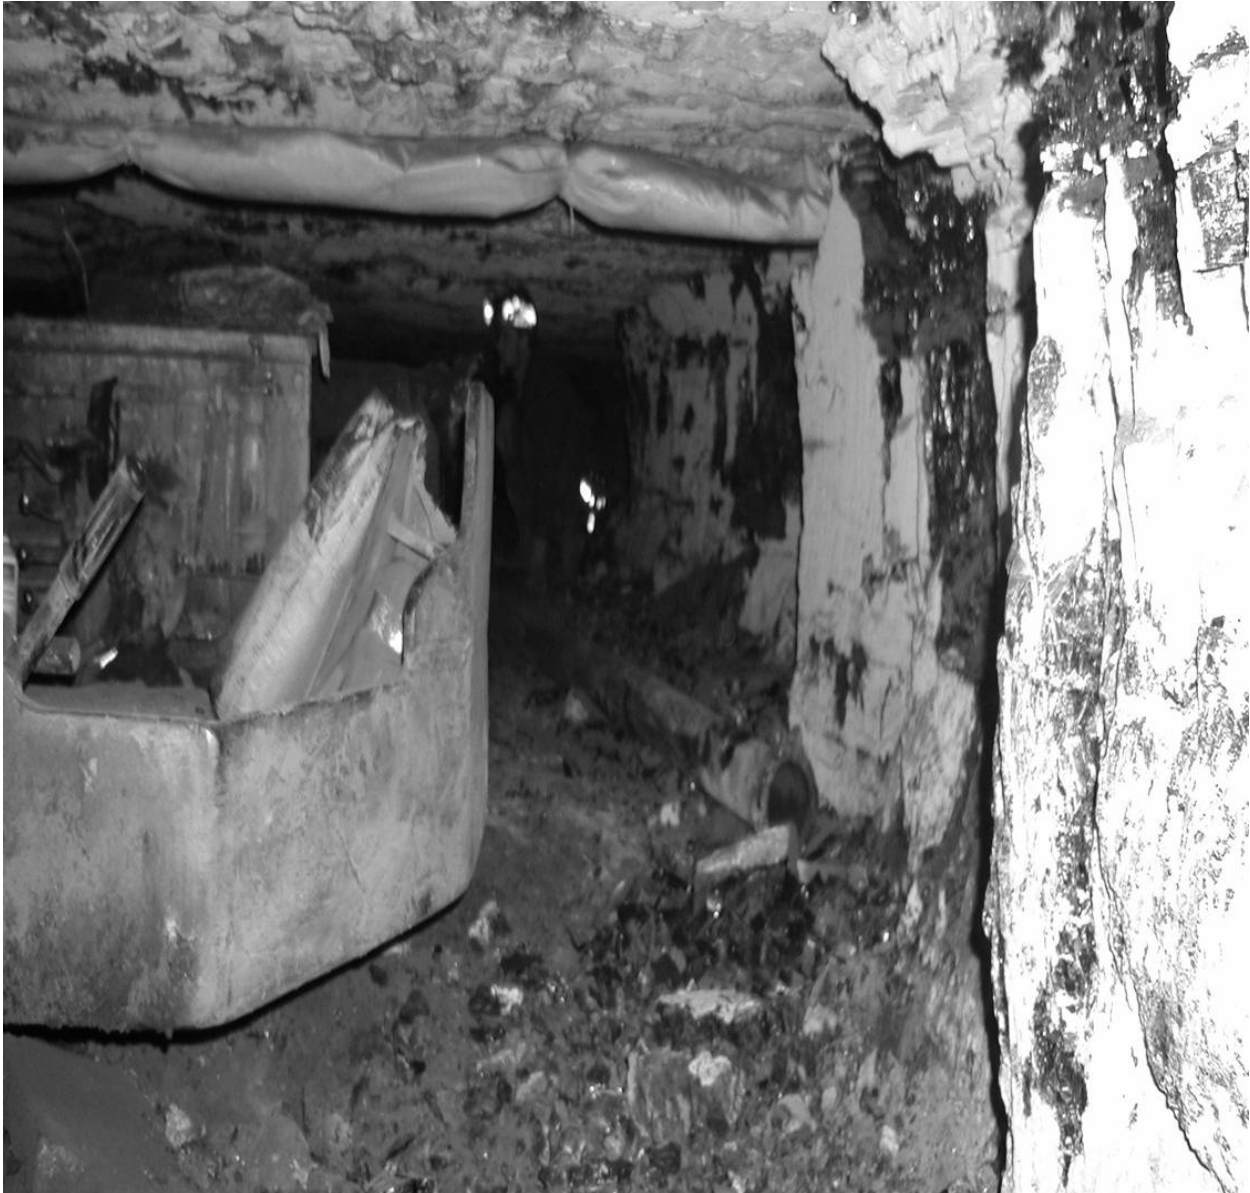
Causal Factor: A piece of 4-inch diameter plastic water pipe became caught between the bucket of the scoop and the coal rib and was bent by the force of the scoop's motion. The pipe slipped out of the scoop bucket and bounced into the operator's deck of the scoop.

The cause of the accident was failure to remove hazardous, extraneous materials from roadways, haulageways, travelways or other areas of the mine where rubber tired equipment was to be operated. The plastic water pipe and couplings extended into the travelway where a scoop was being operated.

**Photograph of Accident Scene Showing Operator's Compartment of Scoop
and Plastic Pipe**

Corrective Action: Whenever hazardous or extraneous materials are observed in the work area, they should be removed prior to commencing or continuing work.
